LENGTHSCALE ISSUES IN THE MECHANICAL BEHAVIOR AND FAILURE OF COMPOSITE STRUCTURES

Final Technical Report for work conducted during the period February, 2007 through January, 2011 under Award with the Office of Naval Research

May, 2011

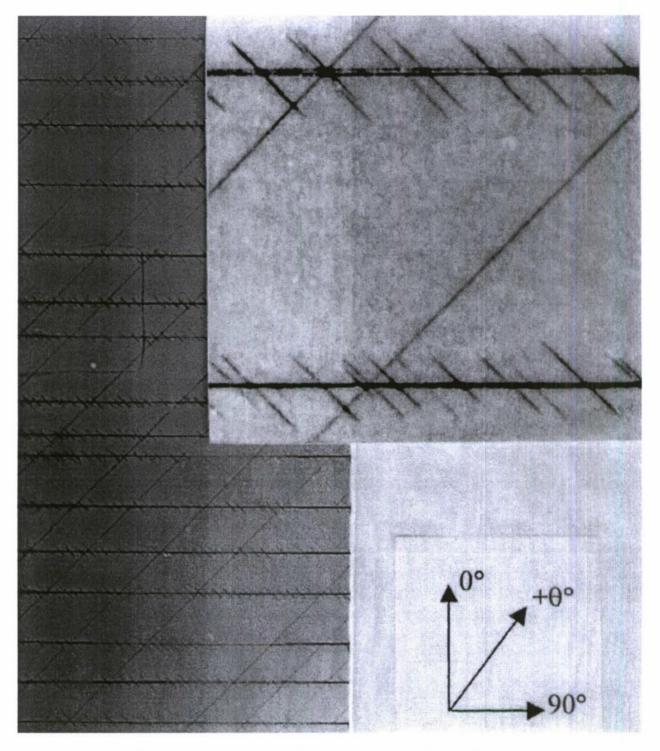
Figure 9. X-radiograph illustrating stitch cracks (along the -45° direction) formed along major matrix cracks (along the 90° direction) in a $[+45_4/-45_4/90_8]_S$ laminate [79].

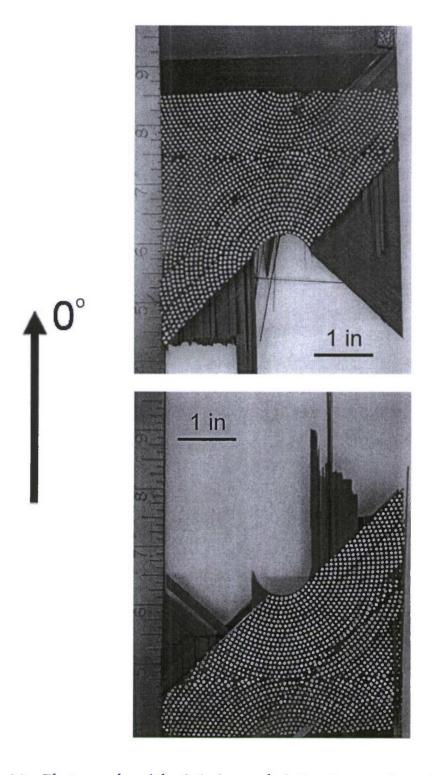
Figure 14. Photographs of the failed open-hole tension specimen OH-B104-04, with hole diameter of 1.0 inches, showing (*upper*) actual back, upper-half face, and (*lower*) actual back, lower-half face.

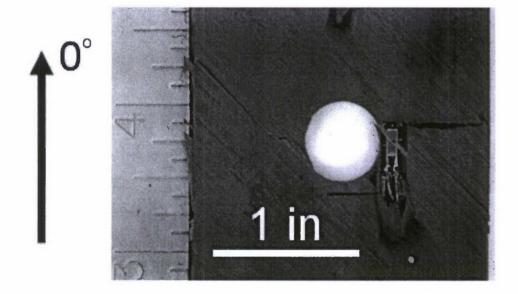
Figure 18. Photograph of the failed open-hole tension specimen OH-A051-01, with hole diameter of 0.5 inches.

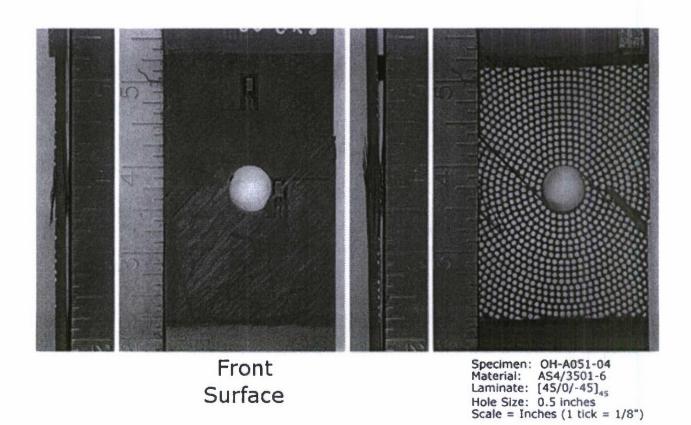
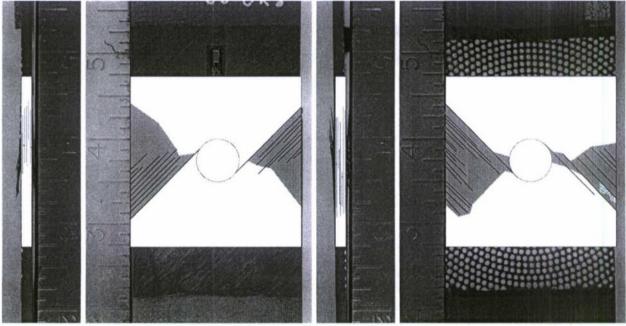
Figure 20. Photo documentation of OHT specimen OH-A051-04.

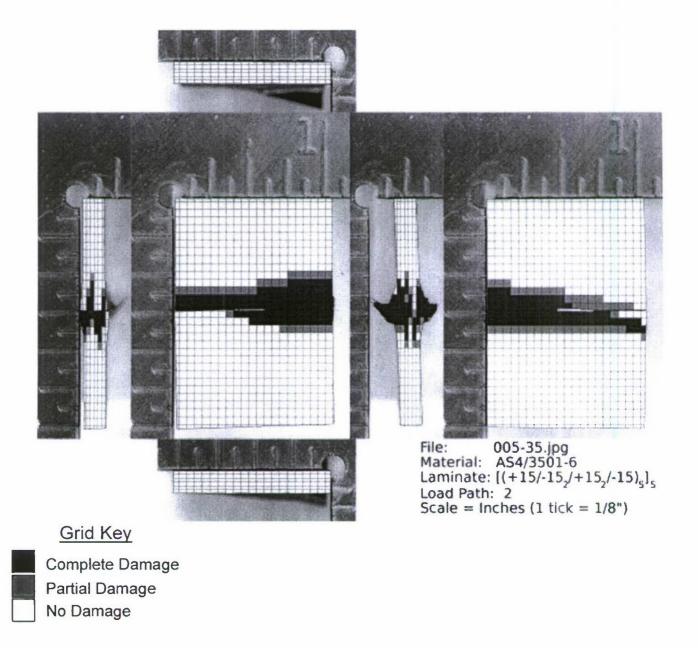
Figure 25. Damage grid of previously tested NRL IPL specimen 005-35 indicating typical visualization of the extent of damage in the specimens.

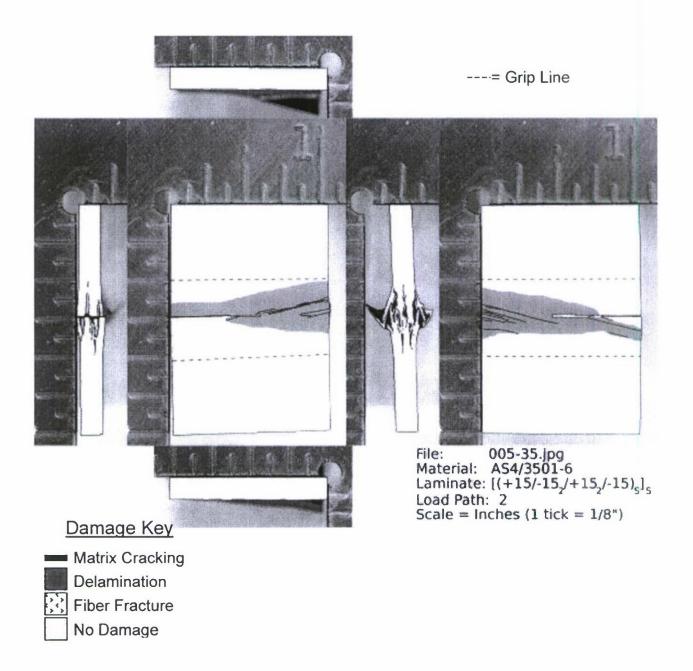
Figure 26. Damage sketch of previously tested NRL IPL specimen 005-35 indicating typical damage in the specimens.

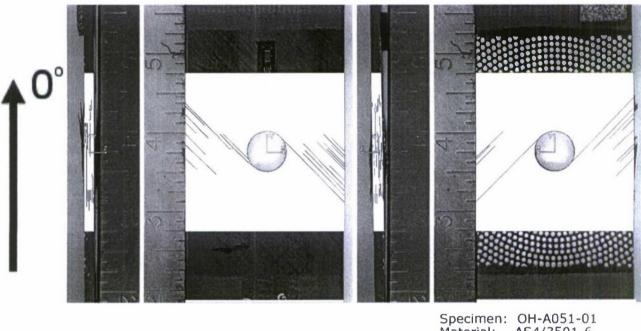
Figure 30. Damage sketch of the failed open-hole tension specimen OH-A051-01, with hole diameter of 0.5 inches.

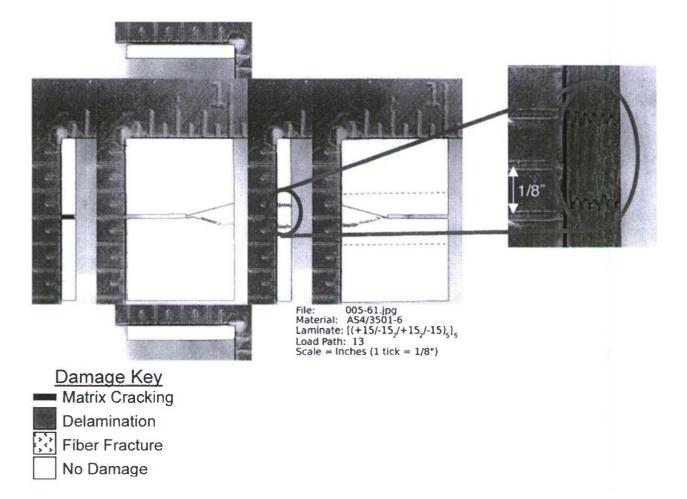
Figure 31. For the NRL IPL specimen 005-61 exhibiting the 'zig-zag' damage mode, (*left*) the overall damage sketch, with (*right*) the enlarged photograph of the 'right face'.

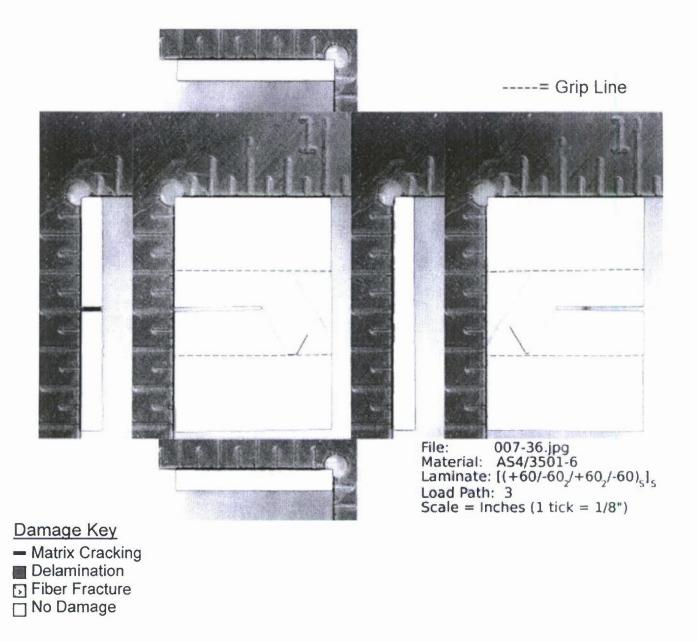
Figure 32. Damage sketch of NRL IPL specimen 007-36 indicating a boundary (lengthscale) effect present in some specimens.

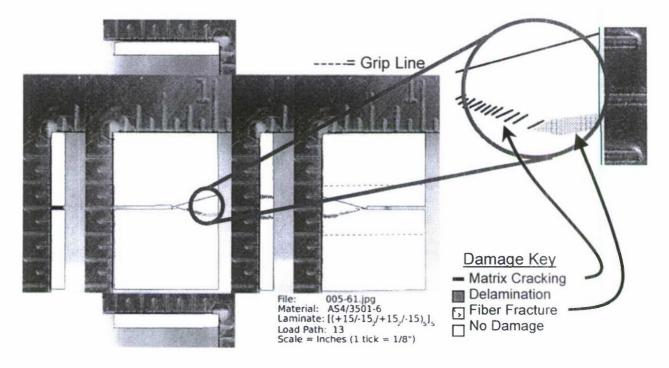
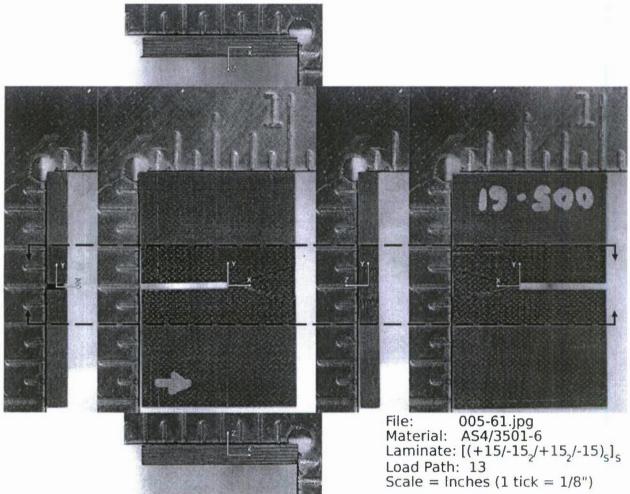
Figure 33. For the NRL IPL specimen 005-61 indicating a damage mode change along the damage progression path, (*left*) the overall damage sketch, with (*right*) the enlarged image of the particular damage.
